Air & dirt separator up to challenge of hotel's iron oxide problem

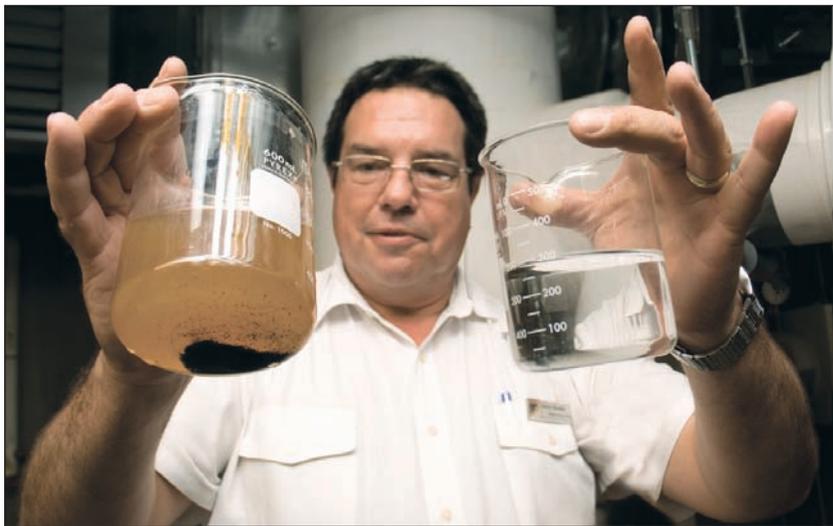
Steve Beretta, the hotel's Director of Engineering, holds a beaker full of the crud and gunk that collected in the new hotel's hydronic piping, and compares it to the clean, oxygen-starved water from the system after installing Taco's 4900-AD separators.

fall for the heating side. Once operational, the system water, now being starved of oxygen, began to show improvement right away, according to Steve Beretta. In four months' time the problem was gone and heating and chilled system water had turned clear and sediment free.

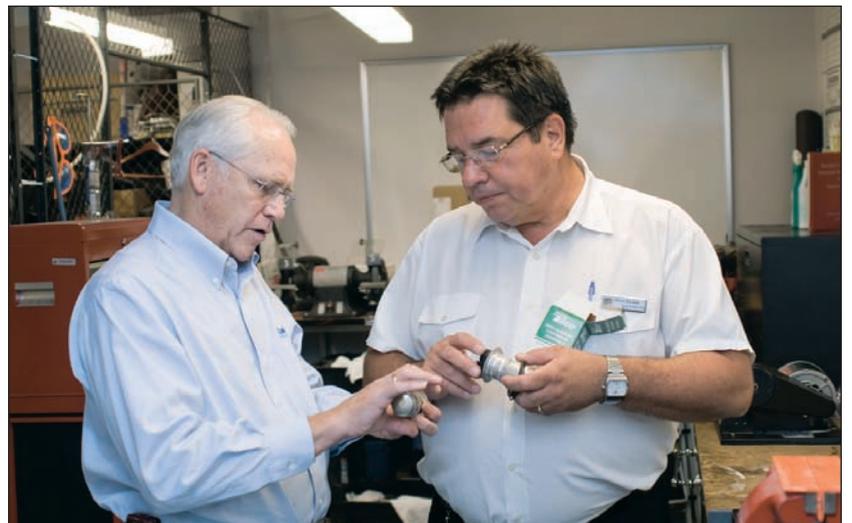
Taco's Greg Cunniff (left) explains to Steve Beretta the PALL ring technology that separates microbubbles, sand, dirt and rust from the water in the hydronic system, thereby preventing the growth of damaging microbes.

systems. The key to the 4900 Series' effectiveness is its use of patented stainless steel PALL rings. Pall ring technology is widely used in the processing industry to mix or separate gases from liquids. Using PALL rings in hydronic air separation allows removal of microbubbles, sand, dirt and rust. Air bubbles are separated by the PALL rings through a process known as coalescence; dirt particles are caught and sifted to the bottom of the tank, where they can be removed through a blowdown valve.
